## Minerals Inspection Report

Mine Name: Diamond Mountain Resources	Permit Number: M/47/0066	Mine Status: Active
Operator Name: Deseret Generation and Transmission	Inspection Date: 08/20/2014	Permit Fees: Paid
Inspector(s): A. Abate	Inspection Time: 9:30 AM	Bond Amount: \$275,000
Attendee(s): E. Olsen, B. Dickson, J. Baker	Weather: Overcast 60'sF	Bond Escalation: 03/17/2015
Inspection Purpose: Routine and discussion of future expansion activities		Prior Inspection: 6/2010

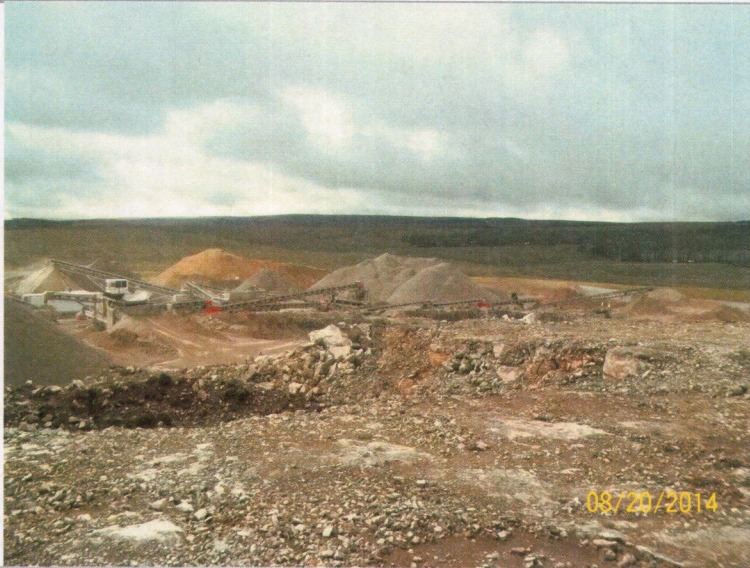
View of the mine operation looking toward the southwest.

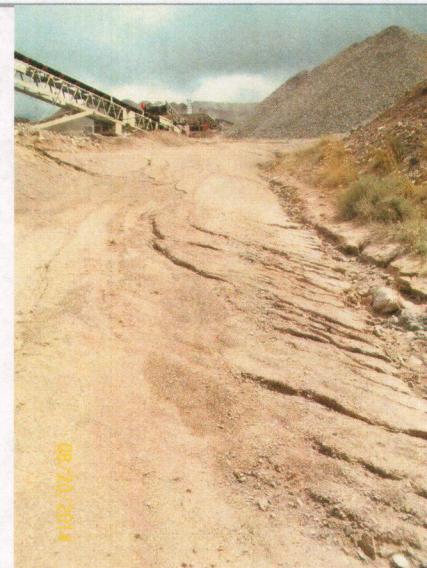
4. <i>Deleterious Material</i>	<input checked="" type="checkbox"/>	<input type="checkbox"/>
None observed.		
5. <i>Roads (maintenance, surfacing, dust control, safety)</i>	<input checked="" type="checkbox"/>	<input type="checkbox"/>
Some erosion problems were noted along the east haul road. Safety and dust control measures are routinely undertaken.

Some erosion problems were noted along the east haul road of the mine.

3. <i>Protection of Drainages/Erosion Control</i>	<input checked="" type="checkbox"/>	<input type="checkbox"/>
Some minor erosion problems were identified along the road and near the sediment ponds. The operator indicated that corrective actions would be undertaken.

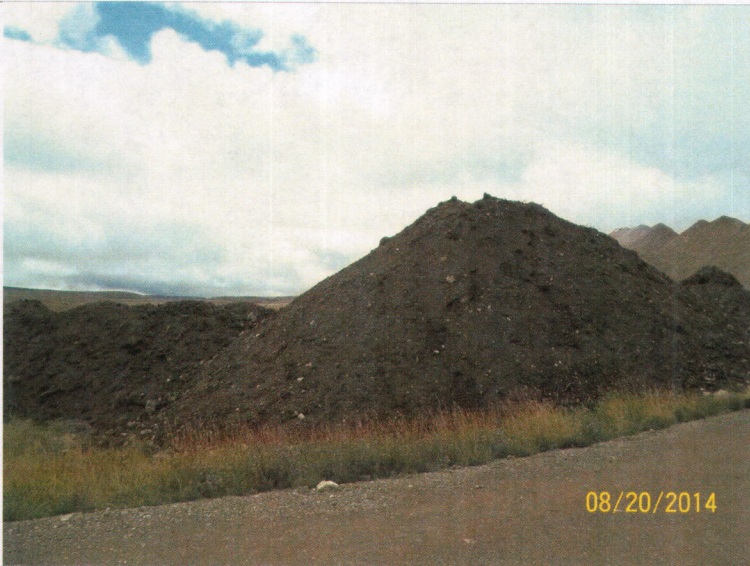
8. <i>Soils</i>	<input checked="" type="checkbox"/>	<input type="checkbox"/>
Topsoil piles were salvaged and observed to be in the same area as shown on the 2012 Progress Map. At the operators discretion, the Division recommends labeling the piles "Topsoil".

Topsoil salvage piles.

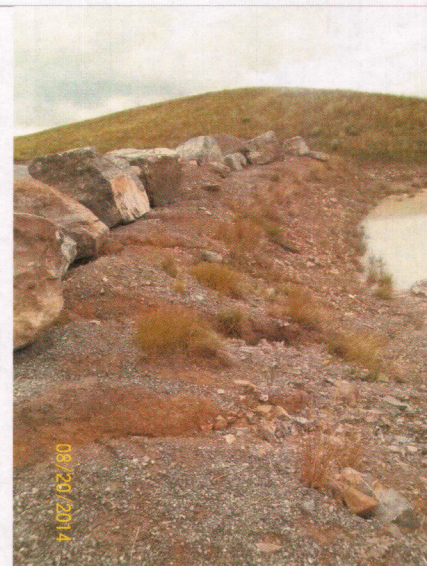
Erosion problems were noted near the sediment pond on the southwest corner of the operation.
